Numerical Simulation of Galvanic Corrosion Caused by Shaft Grounding Systems in Steel Ship Hulls

Y. Wang

Defence R&D Canada – Atlantic

Technical Memorandum
DRDC Atlantic TM 2004-284
January 2005

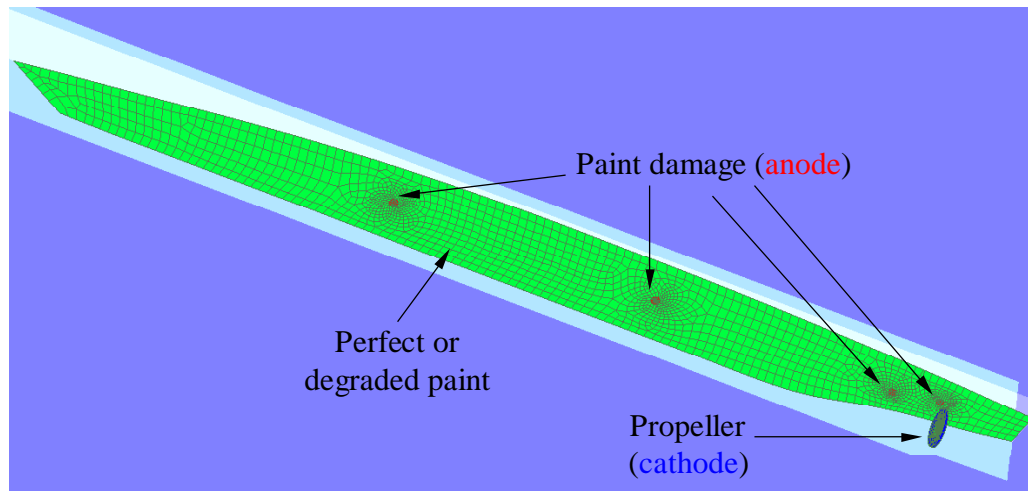
Figure 1. Ship model for galvanic corrosion modelling.

The model under consideration is based on a Canadian naval ship. The model, generated using the CPBEM code, is presented in Figure 1. In this study, it was assumed that all paint damage areas on the ship hull are symmetric to the central plane. Therefore, only half the ship hull needs to be panelized and modelled. The model includes a propeller (cathode) and various paint damage areas (anode). The large light area represents the well-painted area (insulation) or degraded paint (anode), depending on the boundary conditions assigned in the area. The propeller, which is made of nickel-aluminum bronze (NAB), was modelled as a disk with the cathodic area on the disk equal to the surface area of the NAB propeller. The NAB disk is electrically connected to the ship hull although the shaft was not included in the model. A total of 1160 to 2050 elements were used in the model, depending on the number of paint holidays modelled, with smaller elements assigned to the area adjacent to the anodes. This mesh design will facilitate the smooth variation of the potential profiles expected in this area.

In most simulations conducted in this study, the model with a single paint damage site was used to investigate the effect of paint damage area and damage location on galvanic corrosion rate, while the model with four paint damage areas was used to study the distribution of galvanic corrosion current along the ship hull in both open-sea and alongside scenarios. The seawater conductivity of $0.032 \Omega^{-1}cm^{-1}$ was used in the modelling study.

In another modelling trial, four paint damage sites of the same damage size (0.3 m^2) were assigned on the steel hull (see also Figure 1) in order to demonstrate the distribution of the galvanic corrosion current on the hull. Two fluid domains were taken into account: an infinite domain accounting for a ship in an open sea and a finite domain for a ship in a shallow water zone (e.g. alongside). In the finite domain, a quarter box was added to serve as the outside boundary of the domain. The dimension of the quarter box was 200 m long, 20 m wide and 10 m deep. The depth of 10 m is a typical water depth near the jetties in the Halifax harbor.

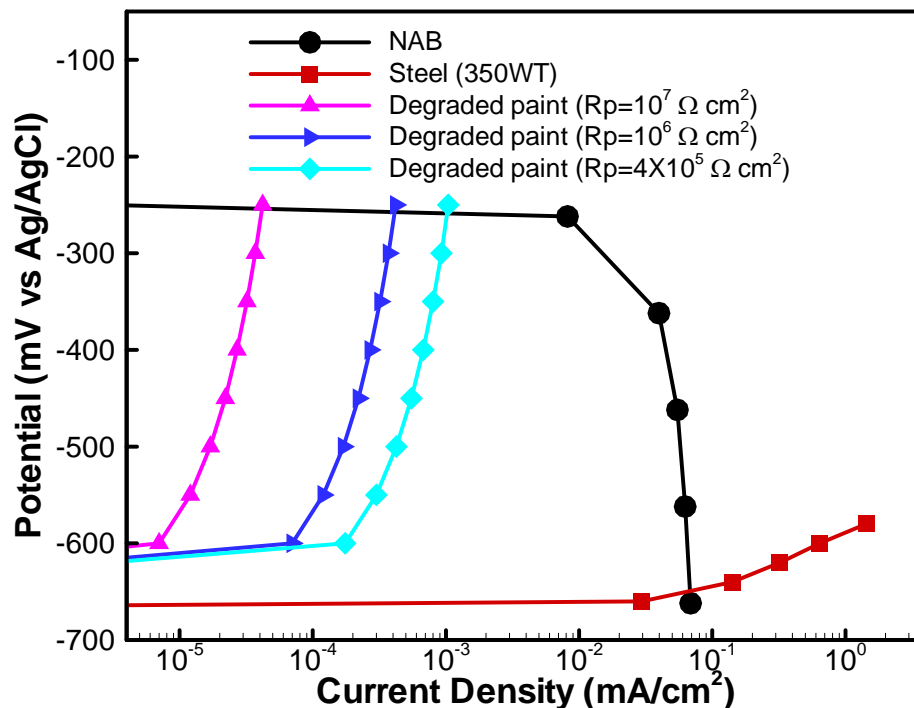
Figure 2. Polarization curve data for NAB, 350WT steel and degraded paint coating.

The polarization curve data for NAB, 350WT steel and degraded paints are presented in Figure 2. Those polarization curves were used as the boundary conditions for the galvanic corrosion modelling. The polarization curve for 350WT steel was used as boundary condition for the paint damage areas where bare steel was exposed. It should be noted that the polarization curves for both NAB and 350WT steel varied considerably with the surface conditions of the alloy or metal, seawater conditions (e.g. composition, O_2 level, temperature), and ship operating conditions (e.g. alongside or at sea). One set of polarization curve data would not be able to predict galvanic corrosion rate for all conditions. The focus of this paper was to conduct parametric studies to investigate the effect of paint damage area and location, and paint degradation on the distribution of galvanic corrosion current, instead of predicting exact galvanic corrosion rate.

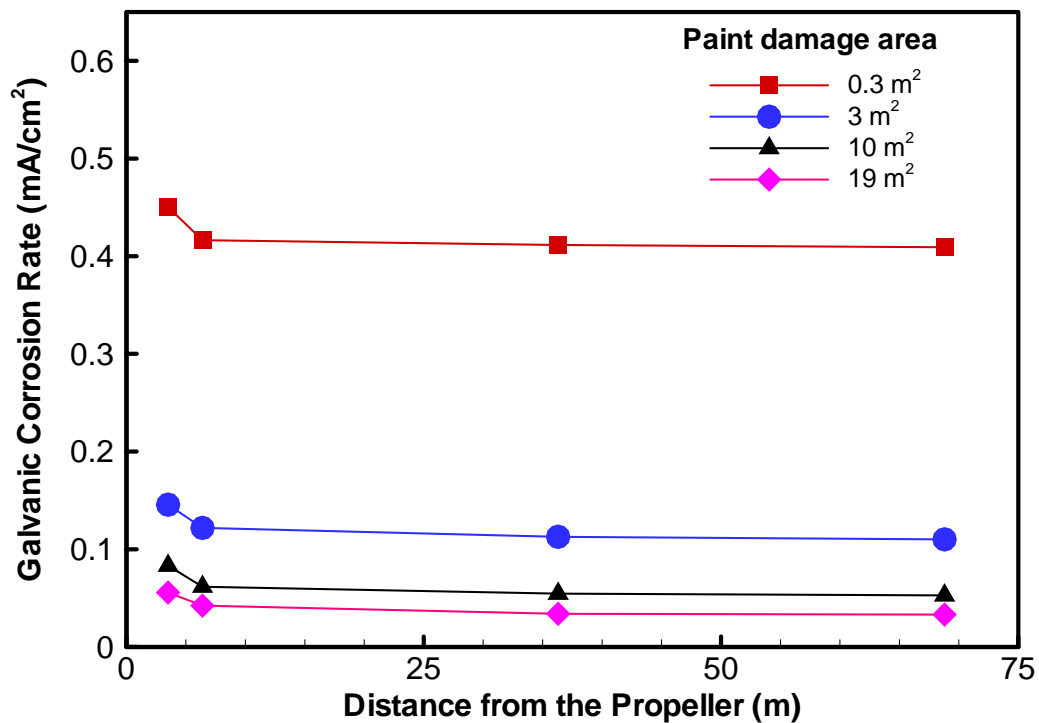
Figure 3. Galvanic corrosion rates as a function of distance from the propeller

The predicted galvanic corrosion rates of a single paint damage site at various distances from the propeller are presented in Figure 3. The ship was assumed to be in an open sea so the infinite domain was used. The distance was measured between the center of the paint damage site and the center of the NAB disk. The closest paint damage site on the ship hull to the propeller is the one right above the propeller, which is 3.5 m from the propeller. Figure 3 showed that, overall, the distance does not have significant effect on the galvanic corrosion rate of the steel hull. The galvanic corrosion rate, while slightly higher at the distance of 3.5 m, was approximately the same at the distances of 6.4 m and 68.8 m from the propeller. At 3.5 m from the propeller, the modelling results showed that the predicted galvanic corrosion rate is only 10% and 67% higher than that at 68.8 m from the propeller for the damage areas of 0.3 m^2 and 19 m^2 , respectively. Laque²⁰ experimentally demonstrated the distance effect on galvanic corrosion by simulating the possible galvanic action between a bronze propeller and a steel shaft in seawater. In this experiment, several folds of bronze mesh that had an exposed surface area that was equivalent to a bronze propeller were used to represent the propeller. A bare steel pipe and a steel shaft with insulating coating interrupted by a few bare spots at different distances from the propeller were used to represent the steel shaft. The length of the steel pipe was about 12 m. The results showed that the distance effect was great only within a short distance from the propeller. In both test cases the galvanic corrosion rate of the steel was approximately the same along the steel pipe after 1 m from the propeller. As mentioned before, the closest spot to the propeller on the steel hull is 3.5 m from the propeller. The modelling results in this study indicated that if there were one paint holiday on the under-water hull, the galvanic corrosion rate would be equally great no matter where the paint holiday was located on the wetted hull.

The results in both Figure 3 and Figure 4 also indicated that the solution resistance between the anode and the cathode is affected not only by the distance in between, but also by the sizes of both anode and cathode and the fluid domain. The solution resistance under various scenarios will be discussed in the subsequent section.

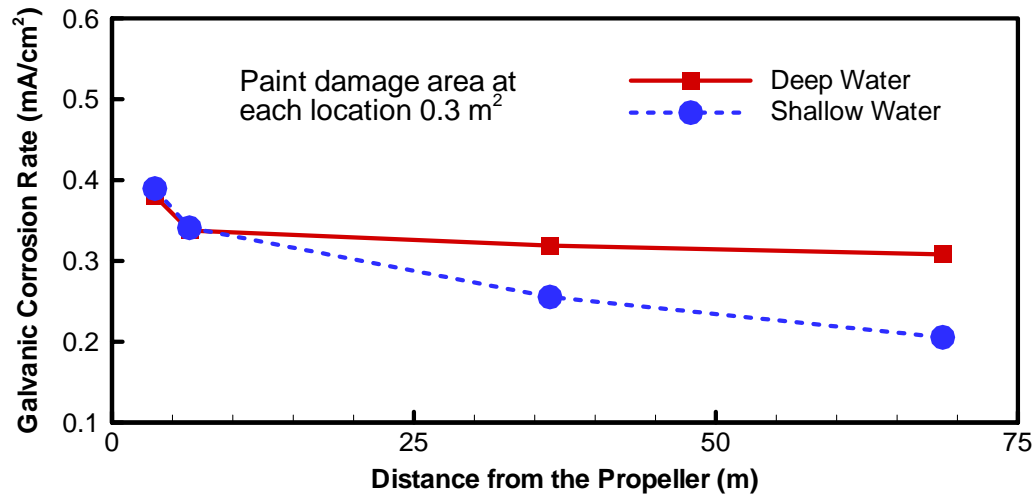
Figure 4. Distribution of the galvanic corrosion current among the four paint damage sites (0.3 m² paint damage at each site).

Figure 4 compared the galvanic current distribution on the paint damage sites along the hull form in the two fluid domains. It can be seen from the figure that the galvanic corrosion currents are more evenly distributed among the four paint damage sites in an open sea than in a shallow water area. The total galvanic current in an open sea was predicted to be 13% higher than that in a shallow water area. These differences in the

galvanic current and the galvanic current distribution are attributed to the change in solution resistance as a result of the change in the water domain where the ship was located (e.g. from an open sea to a shallow water zone).

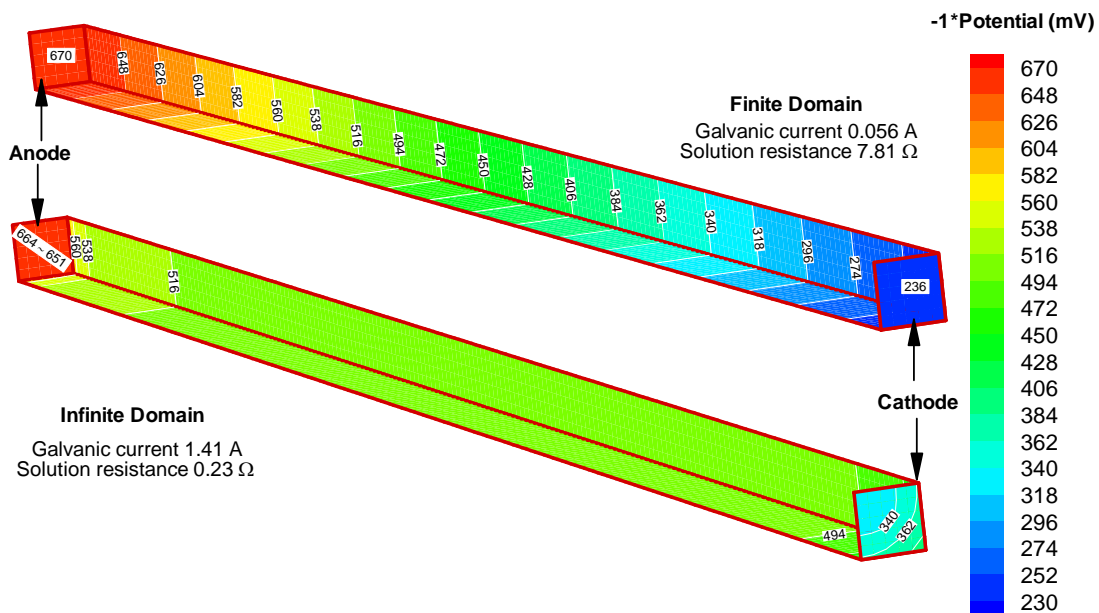
Figure 5. Potential contours on the box surface in both finite and infinite domains.

A box model was built to demonstrate the effect of fluid domain on solution resistance and galvanic corrosion current. The box was assumed to be 100 m long, 4 m wide and 4 m high. One end was assumed as anode and the other one as cathode. The remaining surfaces on the box were assumed as insulation. As the box was symmetric to the longitudinal centerline, the quarter box (i.e. 100 m long, 2 m wide, and 2 m high) was used in the computer modelling. The polarization curve data for the steel and NAB, which are presented in Figure 1, were used as boundary conditions for the anode and cathode, respectively. The same seawater conductivity data was also used for this modelling. Two fluid domains, finite domain and infinite domain, were used. In the finite domain, the box was filled with seawater and the box served as the outside boundary of the domain. In this case, all electrode surfaces faced inward. In the infinite domain, the box was assumed to be surrounded with large volume of seawater, and all electrode surfaces were assumed to face outward.

The potential contours on the box surface in both finite and infinite domains are shown in Figure 5. This figure demonstrated that the two fluid domains produced significantly different potential distributions along the box surface. In the finite domain the potential contours were evenly distributed along the longitudinal direction. In other word, the potential profile along the box had a linear relationship with the distance from the anode. This linear relationship between the potential and the distance from the anode resulted from the constant cross sectional area through which

the galvanic current passes. In the infinite domain, the potential contours were not evenly distributed with much greater potential drop near both anode and cathode surfaces. The potentials on both electrodes were not uniform either in the infinite domain. In fact, the predicted potentials were between -664 mV to -651 mV on the anode and between -324 mV to -394 mV on the cathode. The solution resistance data in Figure 5 also showed that the solution resistance between the anode and the cathode in the infinite domain was over 30 times lower than that encountered in the finite domain. Because of the great difference in solution resistance, the predicted galvanic corrosion current in the infinite domain is much higher than that in the finite domain (Figure 5). The figure also showed that when the box is surrounded by a larger volume of seawater, which is similar to a ship in an open sea, the potential changed only 22 mV over 80% of the box length, compared to the total potential drop of over 260 mV between the two electrodes. This finding indicated that the galvanic corrosion current encountered very low solution resistance when passing through 80% of the box length. The very low solution resistance in this region is attributed to the much larger cross sectional area in the galvanic current path offered in the infinite domain. These modelling results further indicated that in a larger volume of electrolyte the effect of distance became less significant on galvanic corrosion as the galvanic couples were farther apart.

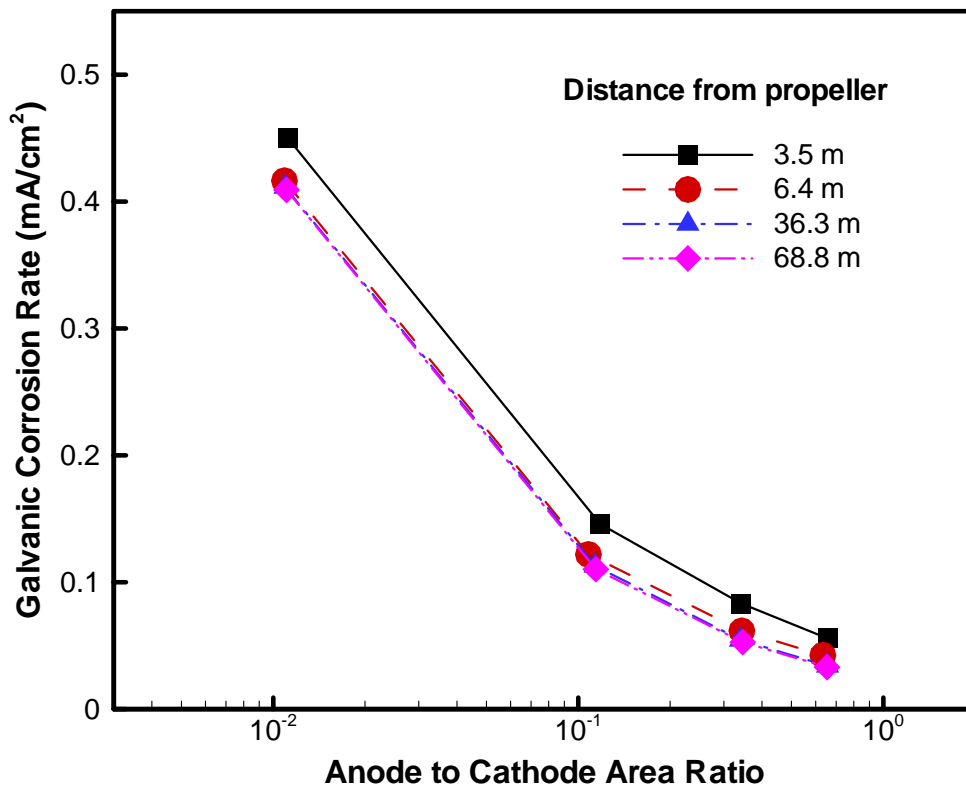
Figure 6. Effect of paint damage area on galvanic corrosion rate.

The paint damage area with a range from 0.3 m^2 to 19 m^2 was analyzed at different locations on the hull in this study. Figure 6 shows the effect of paint damage area, expressed as the ratio of anode to cathode area, on the galvanic corrosion rate. Although the galvanic corrosion current increases as the damage area expands, the galvanic corrosion rate decreases with the increased damage area. It is seen that the galvanic corrosion rate was 8 times higher at the anode-to-cathode area ratio of 0.01 than that at the area ratio of 0.65 no matter where the paint damage was located on the steel hull. Since the hull perforation caused by corrosion is the major concern, a smaller paint damage area would cause more corrosion damage to the steel hull than a larger paint damage area. These results also implied that a ship with a newly painted steel hull, which has fewer and smaller size of paint holidays, would be more likely subject to severe galvanic corrosion damage.

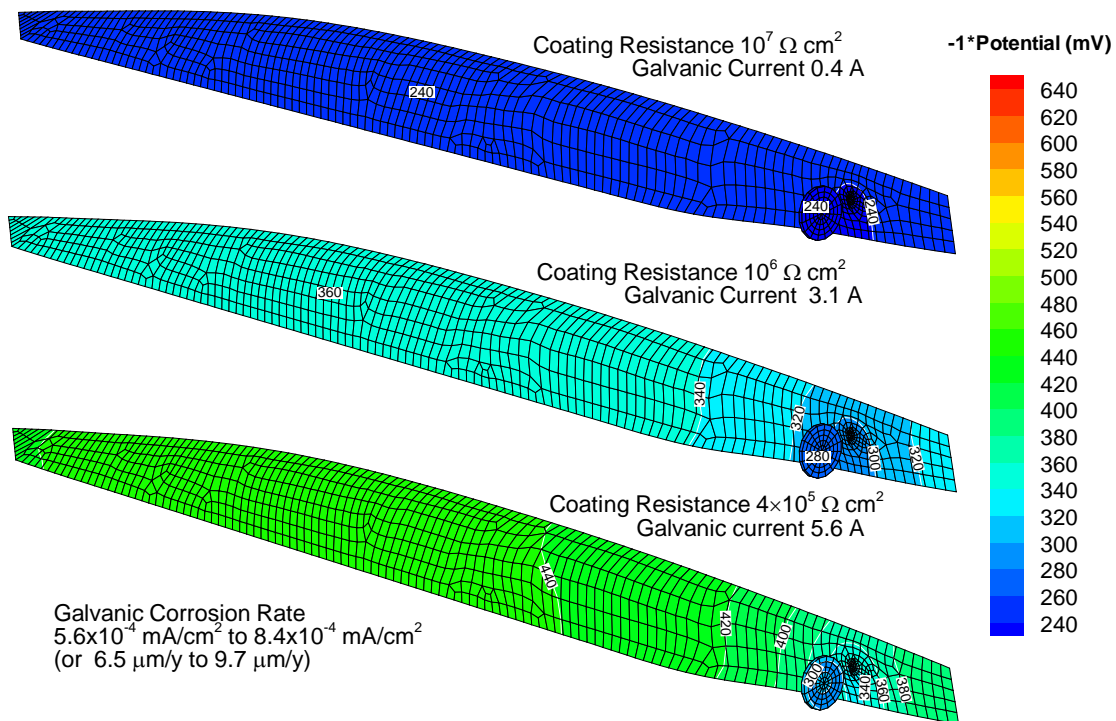
Figure 7. Potential contours on the ship hull computed at various stages of paint degradation.

The predicted potential contours and galvanic corrosion currents at various stages of paint degradation are presented in Figure 7. This figure shows that the coating resistance on the steel hull affected the overall hull potential levels and galvanic corrosion current. The predicted potentials were close to the open circuit potential of the NAB on the paint coating with high coating resistance. As the coating resistance decreased, the potential values on the hull shifted negatively toward the open circuit potential of the steel. The predicted galvanic corrosion current increased from 0.4 A to 5.6 A when the coating resistance decreased from $10^7 \Omega \cdot \text{cm}^2$ to $4 \times 10^5 \Omega \cdot \text{cm}^2$. On the other hand, the simulation results showed that the galvanic corrosion current drawn to the NAB cathode was fairly equally contributed around the whole steel hull. For example, with a galvanic current of 5.6 A, the galvanic corrosion rate was predicted to be between 0.00056 mA/cm^2 and 0.00084 mA/cm^2 around the whole steel hull. The Figure 7 also shows that the potential level on the steel hull reflected the degree of the paint degradation. This result suggests that the electric potentials on the hull that were monitored when the ICCP system was off and the shaft grounding system was left on could be used to estimate the status of the overall paint degradation.

The above modelling results showed that both physical paint damage and the overall paint degradation on the steel hull contributed to galvanic corrosion current when the ICCP system was off and the active shaft grounding system was left on. The overall paint degradation could contribute substantial galvanic corrosion current as the paint coating aged because of very large paint coating area on the wetted hull. However, the sites with physical paint damage contributed much greater localized corrosion rate than that on degraded paint as a result of the smaller area and the much greater polarization current densities on the surface. These results imply that a high galvanic corrosion current does not always mean severe corrosion damage to the ship hull. This high galvanic current may be mainly contributed from the overall paint degradation around the ship hull. It is the total physical paint damage area that determines the extent of the localized corrosion damage to the steel hull.
